14th Street Streetscape Project N.W.
From Thomas Circle to Florida Ave
DC Contract No.: DCKA-2016-C-0043

FAP No.: STP-2016 (054)

CONSTRUCTION MANAGER'S
WEEKLY PROGRESS REPORT
09/10/2018 – 09/15/2018

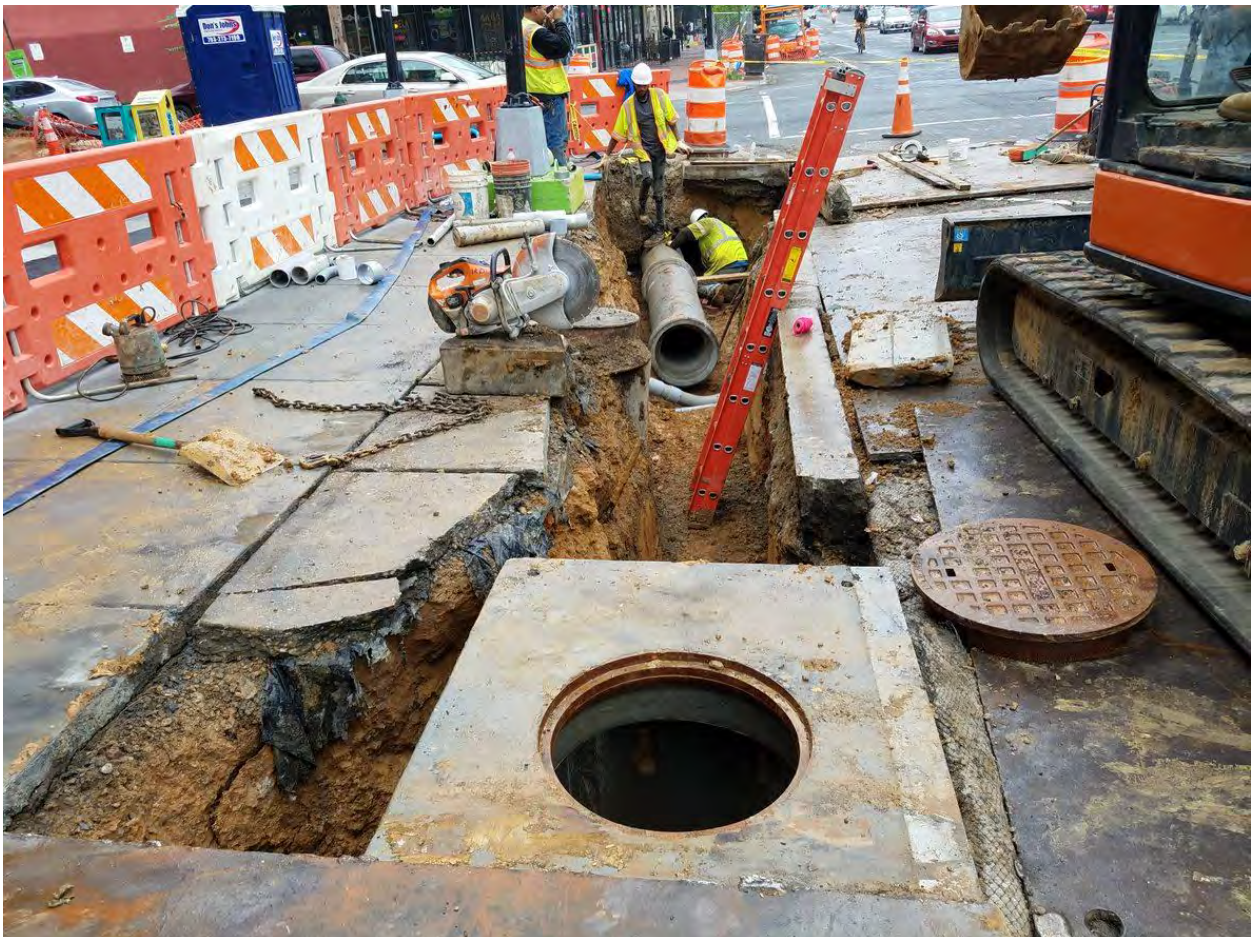
Installing the Connection pipe to Double Catch Basin at NEC of 14th and P Street

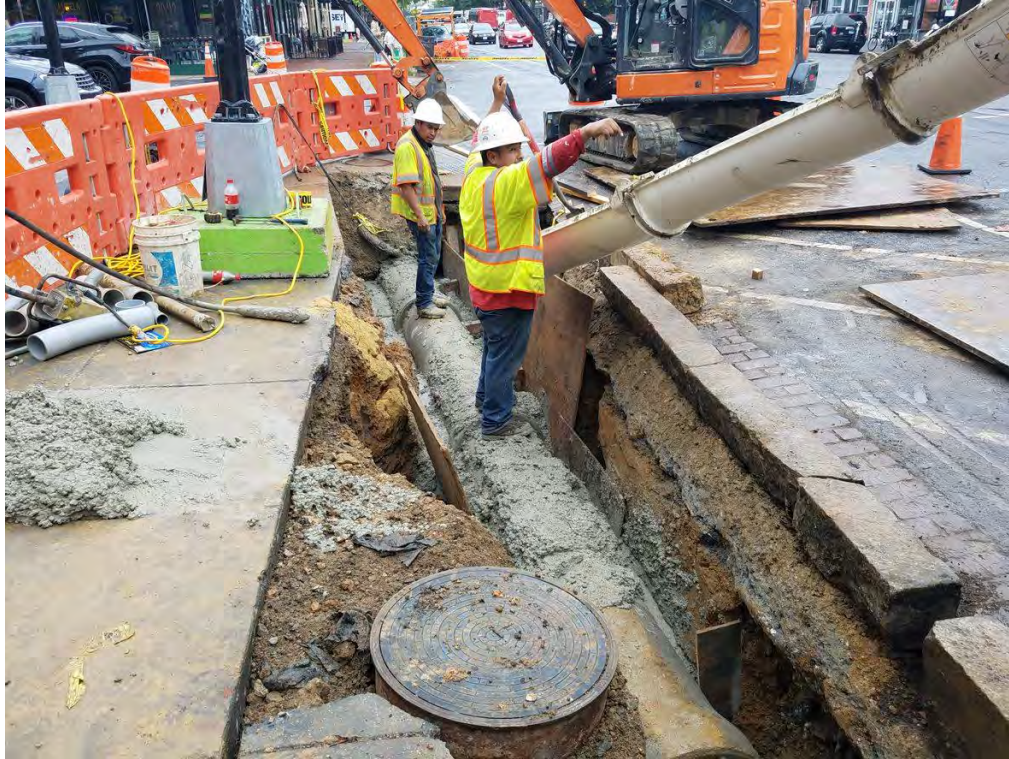
Pouring DC WASA mix for the PCC connection pipe cradle

1. Omni finished installing the 15" PCC connection pipe for CB-07 at the NE corner of 14th and P Street
2. Omni used DC Wasa mix to pour the cradle for the connection pipe
3. Omni continued installing 4" PVC Conduit between MH-38 to MH-39
4. Omni conduit crew cancelled operation at 1pm due to wet backfill material
5. FMCC was onsite providing MOT for these operations

- 9/13/18 DC Wasa Mix 9.0 CY Air was 5.3%, Slump 4.5", a set of cylinders were made

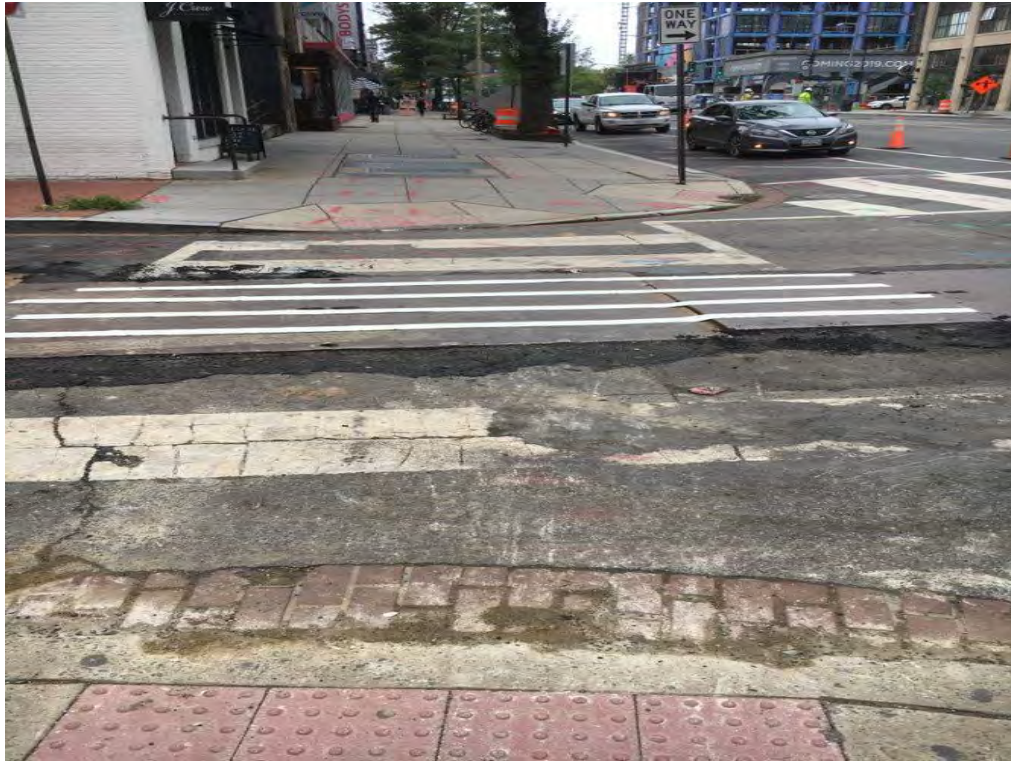
Safety strip placed over Steel Plate

1. Contractor cancelled work activities due inclement weather
2. FMCC / Omni were on site adjusting and securing the Steel Plate based on noise complaint

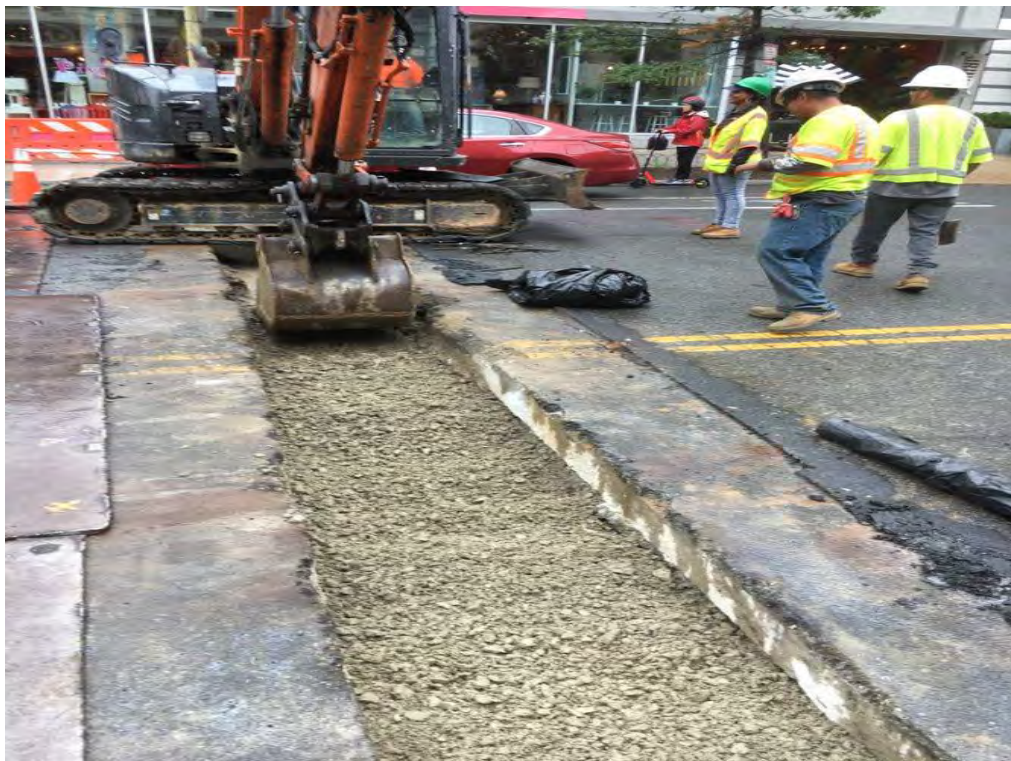
Scarfig Backfill Material to assist in drying of wet material

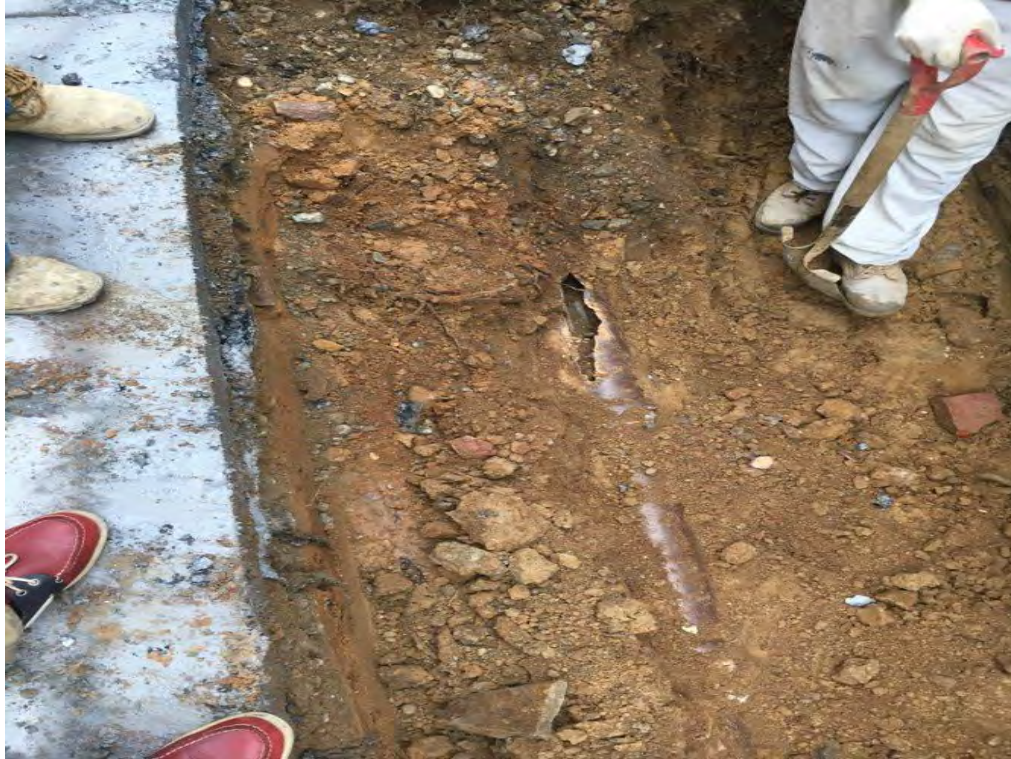
Unmarked Communication Cable found during excavation for CB-08

1. Omni backfilled with RC-6 around CB-07 at the NE corner of 14th and P Street
2. Omni began excavation for CB-08 at the NW corner of 14th and P Street, however an unmarked communication utility was uncovered. Omni is reaching out to Verizon to see if the utility is abandoned
3. Omni placed temporary asphalt between P Street and Q Street over the PCC base in the electrical trenches

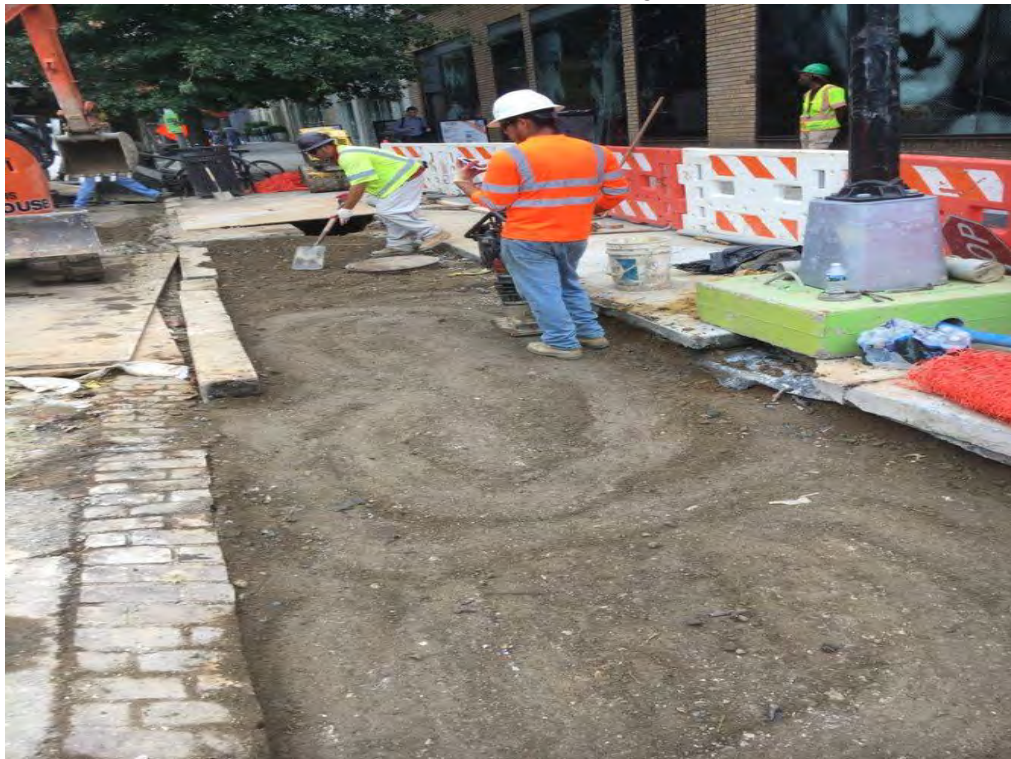
Backfilling of 15" PCC connection pipe for CB-07
